UPPER AND LOWER DAMS

✓  
**PHASE I INSPECTION REPORT**  
**NATIONAL DAM INSPECTION PROGRAM**

National Dam Safety Program

(NDI No. PA 00389,

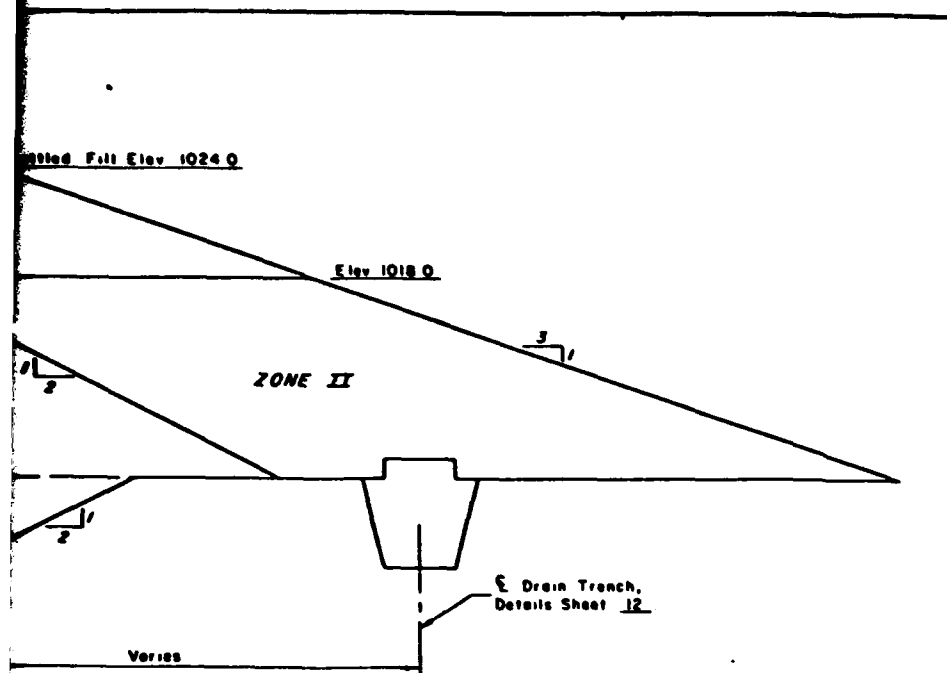
## PLATE 4 AS BUILT PLANS

Zoning - The embankment was constructed in three zones. Zone I consisted primarily of sandy silt (ML) and was placed on the upstream slope and central core of the dam. Zone II consisted of silty sand (SM) and was placed in the downstream slope. Zone III consisted of a silty clay (CL) and was placed in the cut-off trench along the centerline of the dam. (See Plate 4.)

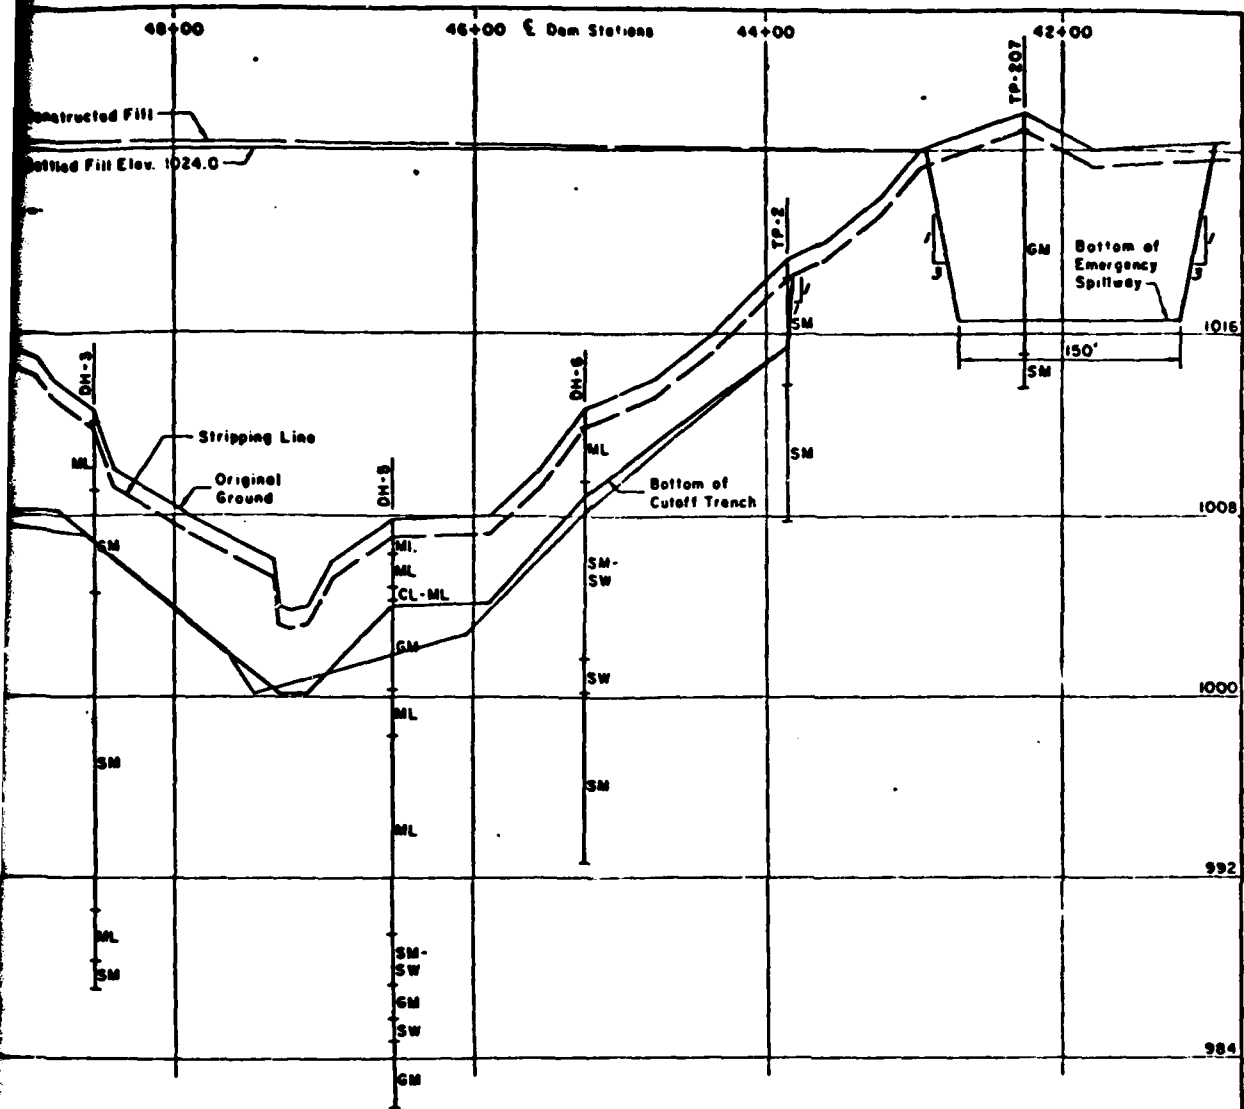
**PLATE 5  
AS BUILT PLANS**

Cut-off - Zone III material, consisting of silty clay (CL), was placed in a cut-off trench along the centerline of the dam. The bottom width was designed at 12 feet with 2H:1V side slopes to stripping grade. The depth below existing ground is shown on Plate 5.

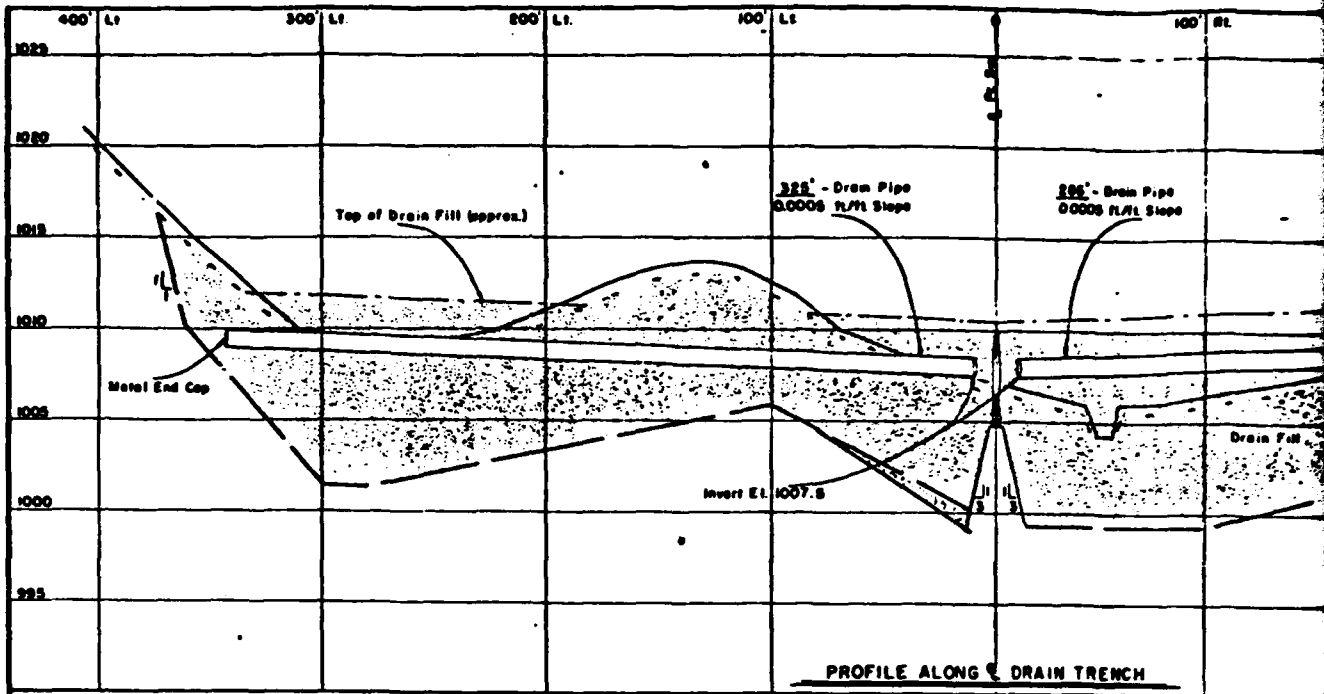
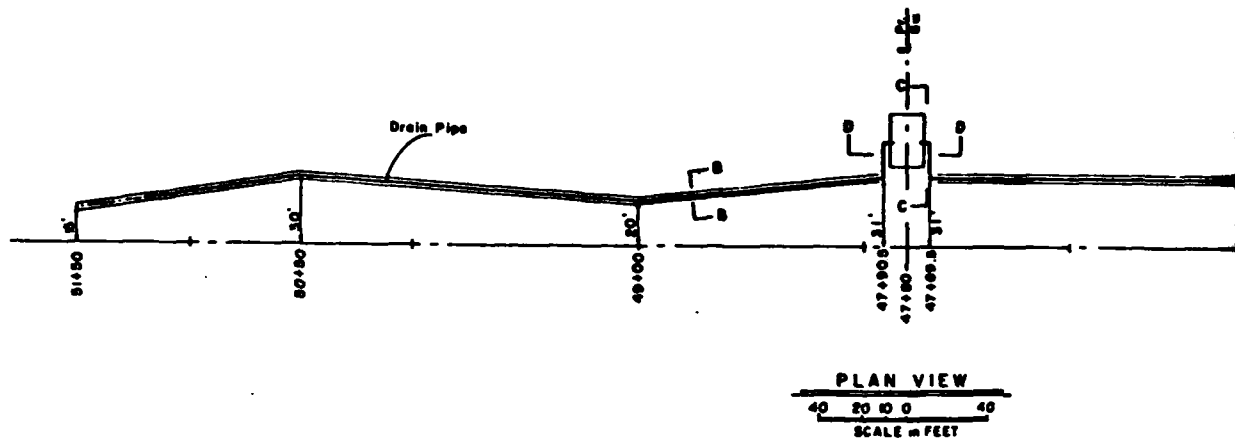
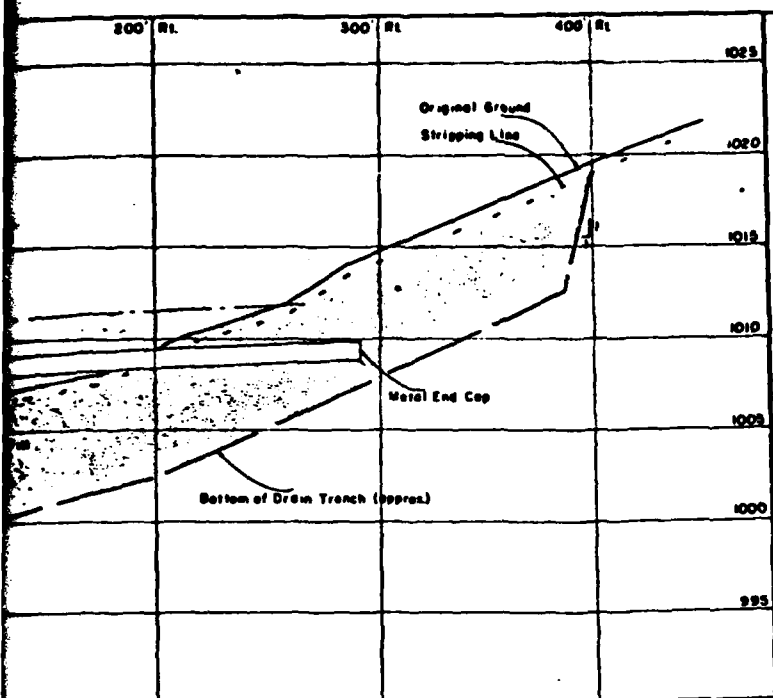
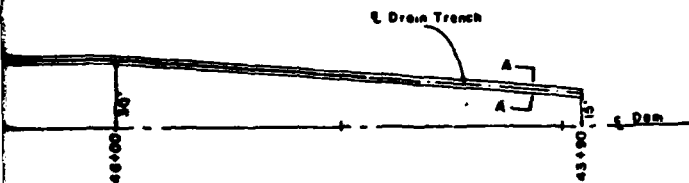
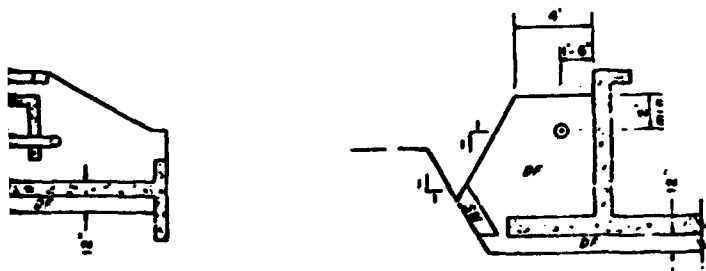
## PLATE 12 AS BUILT PLANS

Drains - The drainage system for the dam consists of a 12 inch diameter perforated asbestos cement pressure pipe in a sand and gravel drainage fill trench. The drainage fill trench runs the entire length of the dam. The drain pipe runs from 370 feet left and 390 feet right of the principal spillway to outlets in the impact basin of the principal spillway. The right drain was flowing at 1 g.p.m. (See Plate 12 for details.)
